**CWA COMPLIANCE EVALUATION INSPECTION REPORT
U.S. ENVIRONMENTAL PROTECTION AGENCY, REGION 5**

Purpose: Compliance Evaluation Inspection

Facility: Ex. 6 (Personal Privacy) Dairy Farms

Date of Inspection: November 21 – 22, 2019

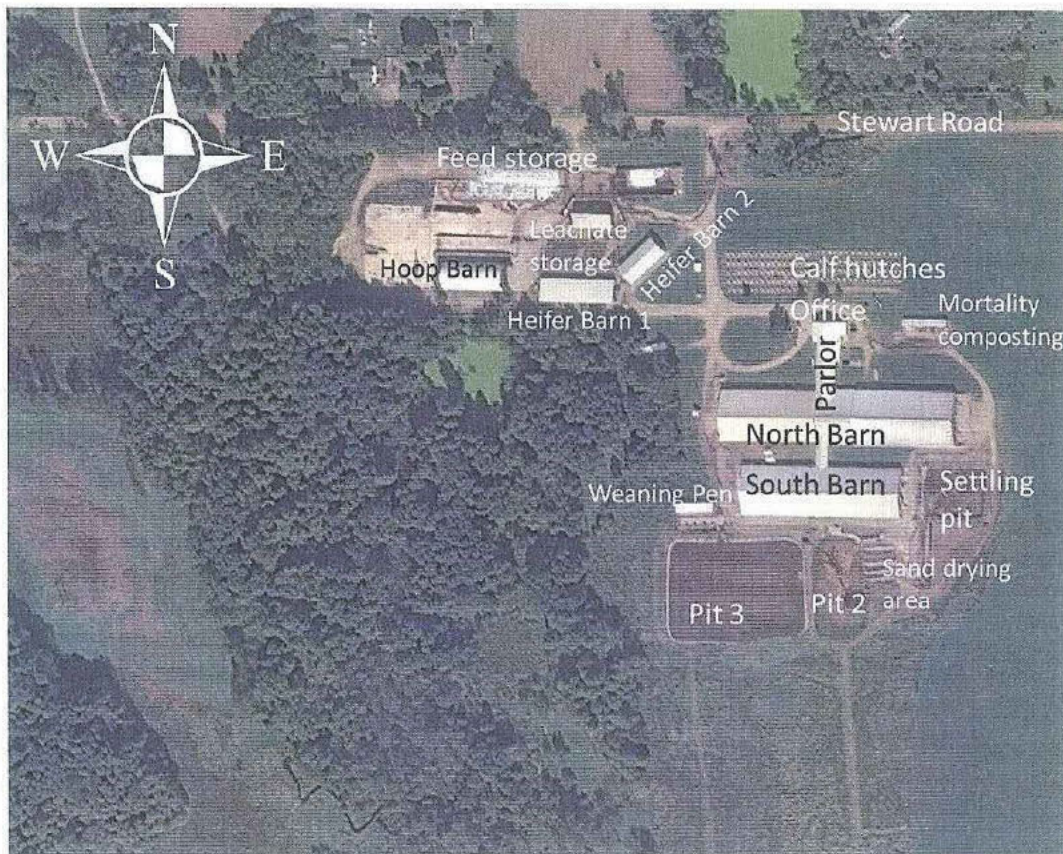
Figure 2. Aerial image of the Facility layout.

Figure 2 is an annotated aerial image of the Facility area that shows the names and locations of the structures inspected. We started from the office and walked southeast towards the north barn. The roof gutters and clean water diversions of the barns drained into a vegetated area between the barns and there was a tile riser that collected runoff and, according to Ex. 6 (Personal Privacy), was connected to an underground County Drain that ran south on the east edge of the Facility (photo 7).

On the east and southeast side of the Facility we observed the sand lane, where all the scrapped sand bedding from the barns goes, the settling pit, connected to the sand lane, and the sand stacking area where sand was left to dry and reused as bedding in the barns as shown in Figure 2. According to Ex. 6 (Personal Privacy), the settling pit was recently dug out and the sand was disposed at the stacking pad area next to it. Ex. 6 (Personal Privacy) stated that the current water depth in the settling pit was 4-5 feet. We did not observe a staff gauge in the settling pit. However, Ex. 6 (Personal Privacy) stated that there was a float control connected to a datalogger that recorded depths.

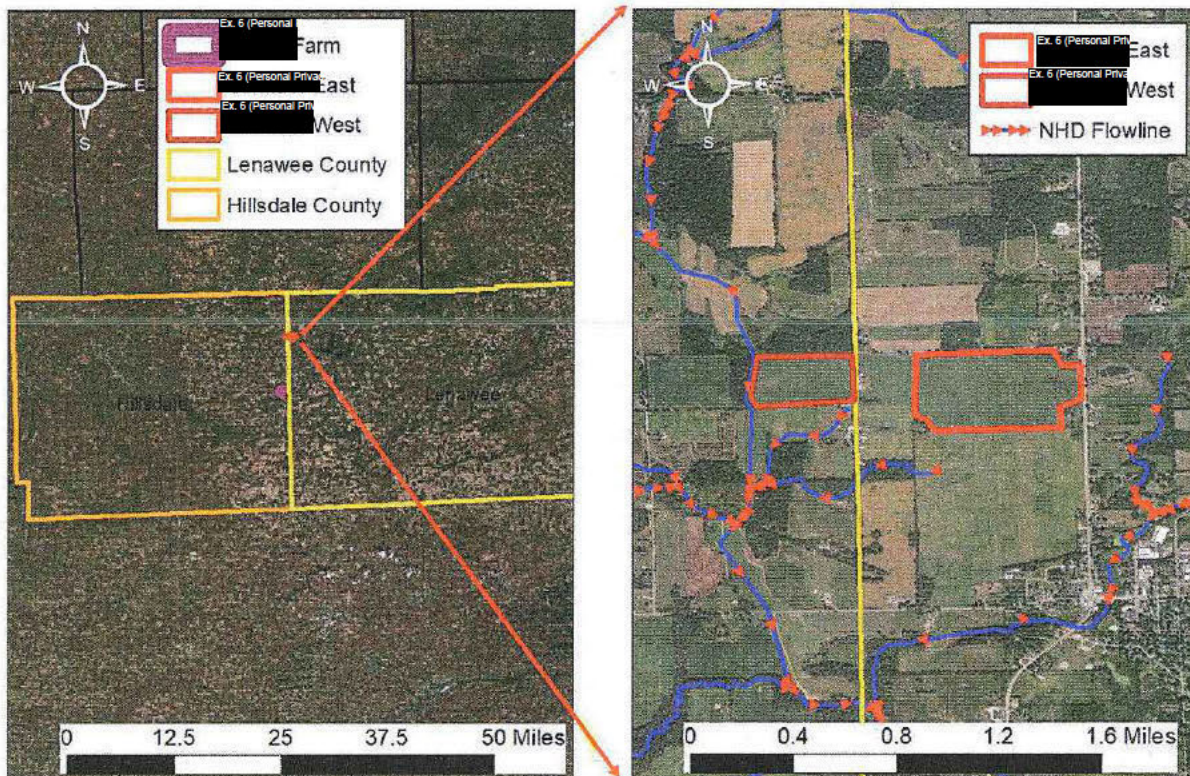
Figure 3. Map showing the locations of the Fields Ex. 6 (Personal Privacy) East and West.

We arrived at Field Schauer East at 8:00 am on November 22, 2019. Field Schauer East is located southeast of the intersection of Defay Road and Meridian Highway. According to Ex. 6. (Personal Privacy) the Facility had applied 70,000 gallons of liquid manure on Field Schauer East on November 21, 2019. We walked around and across the field. We observed pooling liquid manure in a few spots, as shown in photos 57 – 60. Manure had not been incorporated yet. We did not observe any runoff from the field nor did we observe any waterways adjacent to the field, other than a small depression at the southwest corner of the field that had standing water. The depression was not connected to a waterway and it looked like the hauler had kept a 50 – 70 feet setback from it. We did not observe any tile risers in this particular field either.

At approximately 9:20 am we walked across the Meridian Highway to Field Schauer West. According to Ex. 6. (Personal Privacy) manure was last applied to this field on November 8, 2019. We observed a tile riser on the north side of the field in a depressed area with some water pooling around it but no visible flow into it (photo 71). On the west edge of the field we observed a stream (Kempton Drain) flowing south to Fisk Drain then to Bean Creek. There was pooling water on the field approximately 30 feet from Kempton Drain. However, we did not observe any flow towards the stream at the time of the inspection. We left Field Schauer West at 10:20 am and called Ex. 6. (Personal Privacy) to let him know.

Calculations of nutrients applied to these fields were not possible due to a lack of manure analysis reports. Facility did not have these reports on site and did not provide them after the inspection along with other records.

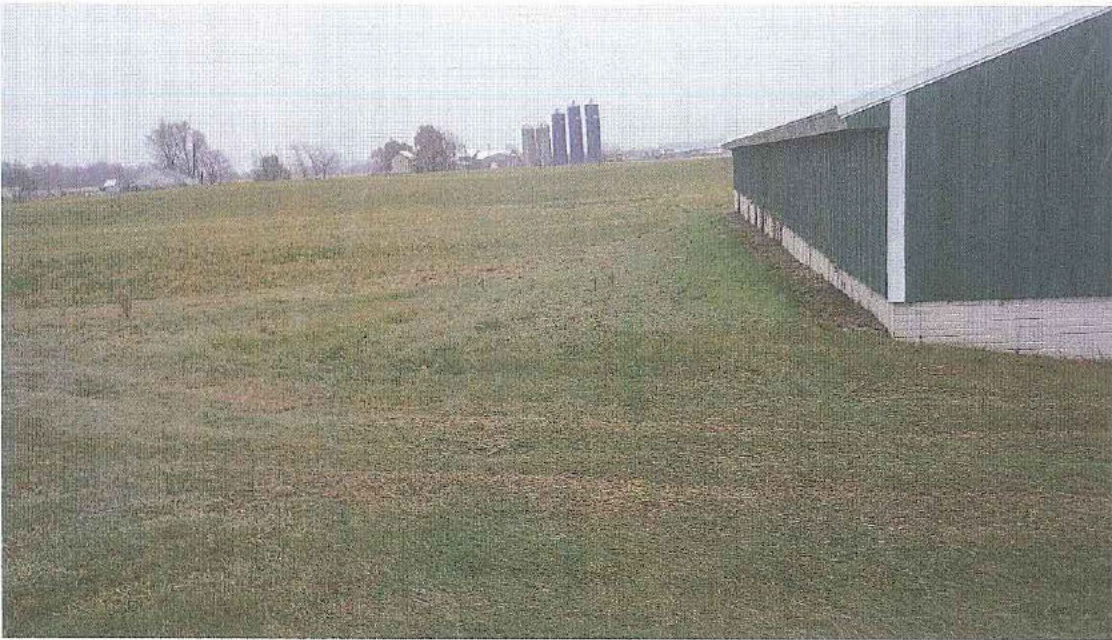
1: RIMG0001

Description: View east along north side mortality composting building.

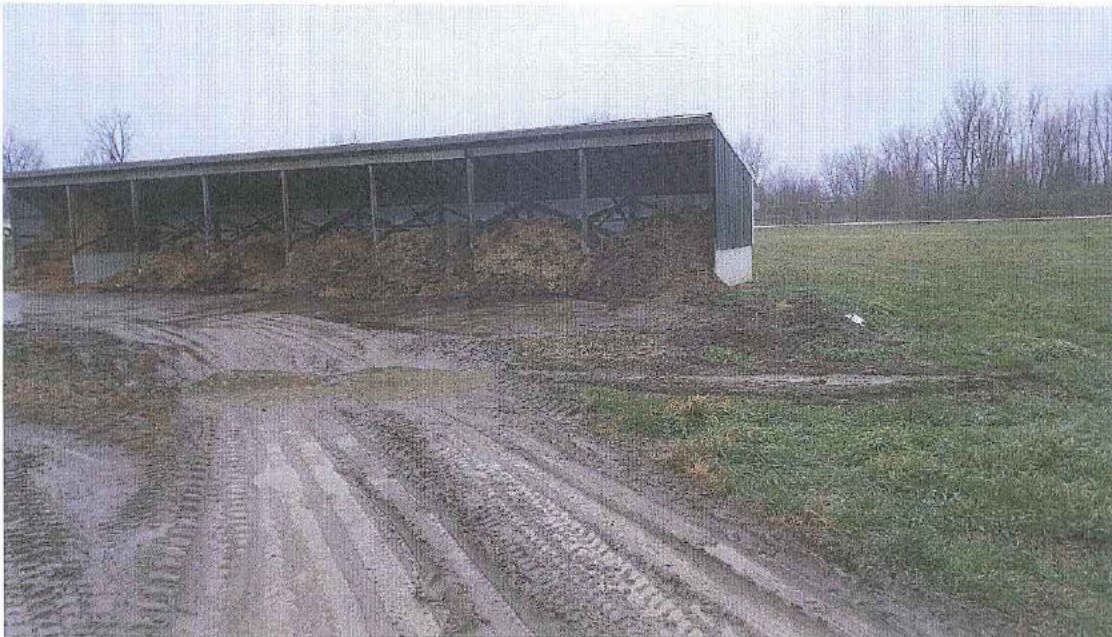
2: RIMG0002

Description: View north at south side of mortality composting building.

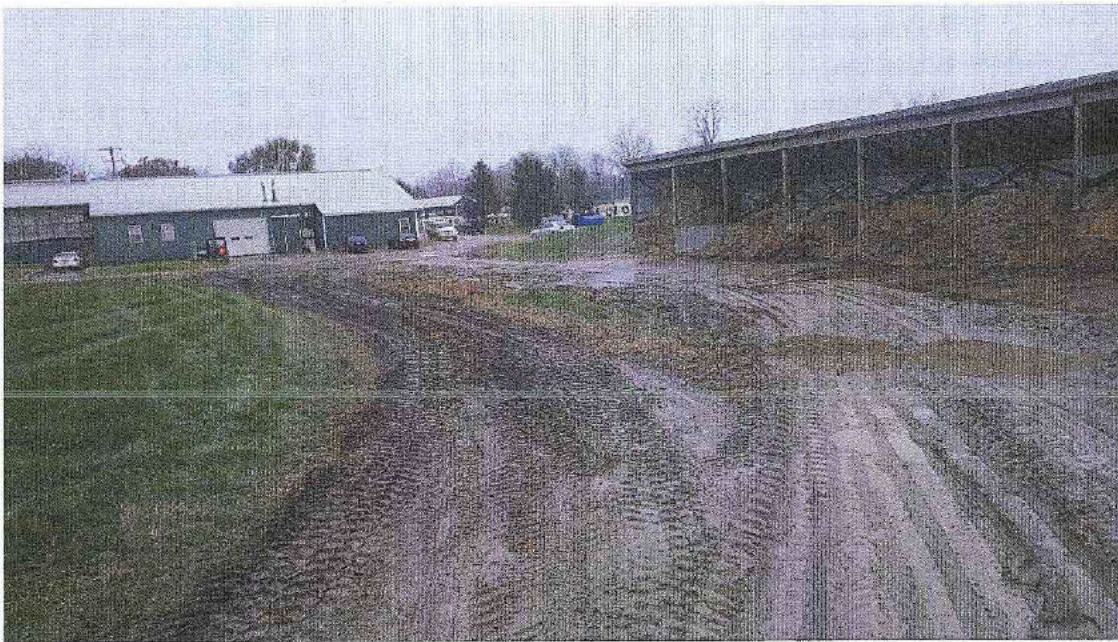
3: RIMG0003

Description: View northwest along south side of mortality composting building (right) with office/milking parlor (left).

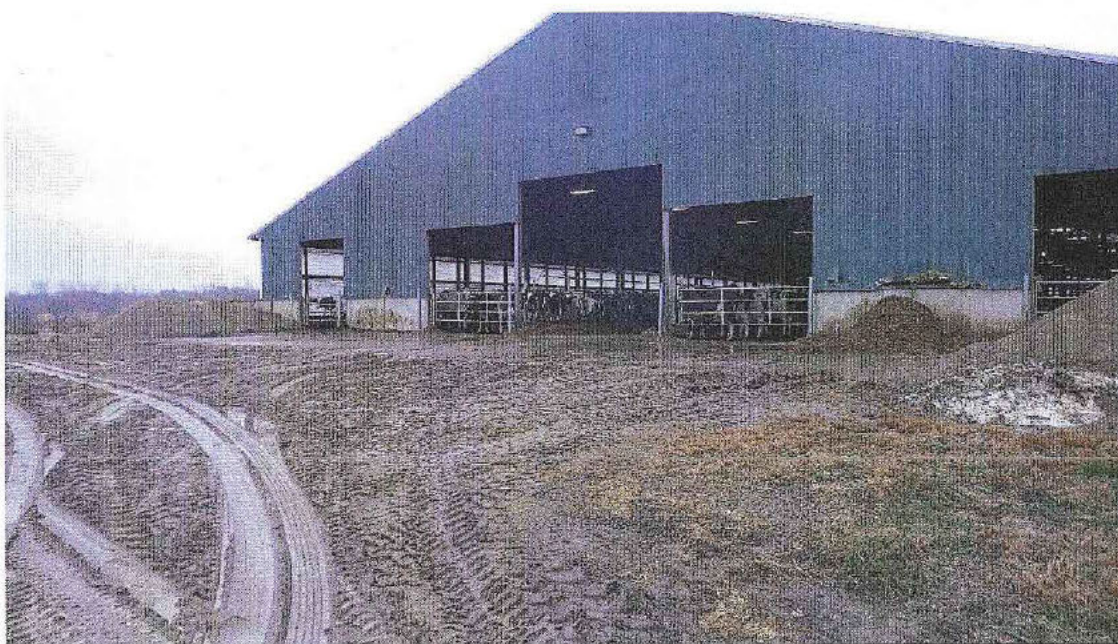
4: RIMG0004

Description: Looking southwest at east end of North Barn.

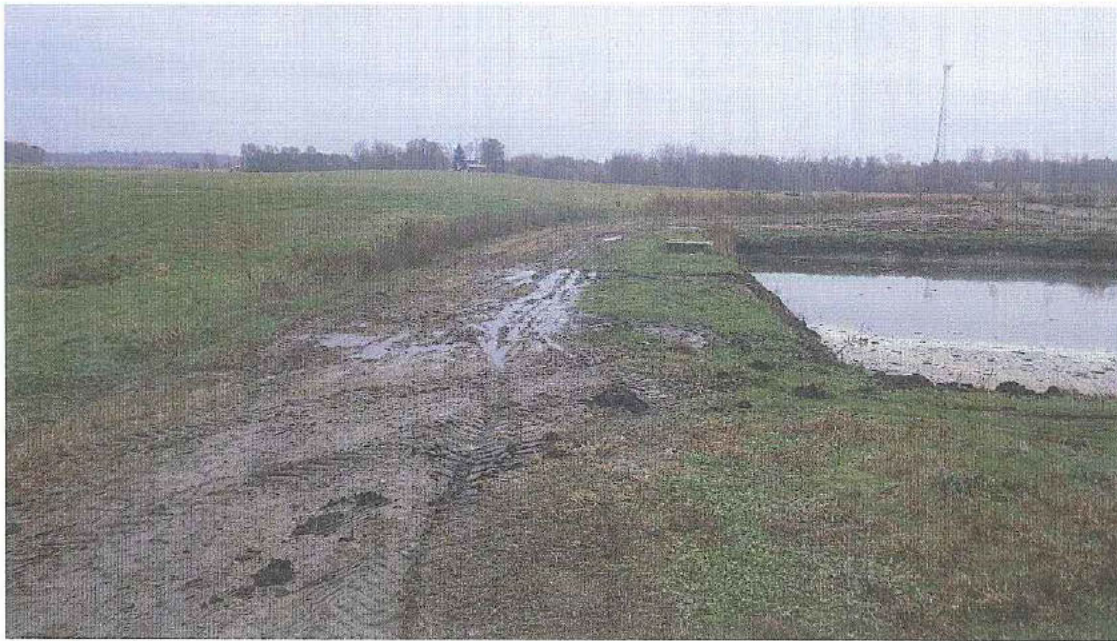
5: RIMG0005

Description: Looking south along eastern edge of manure Pit 2.

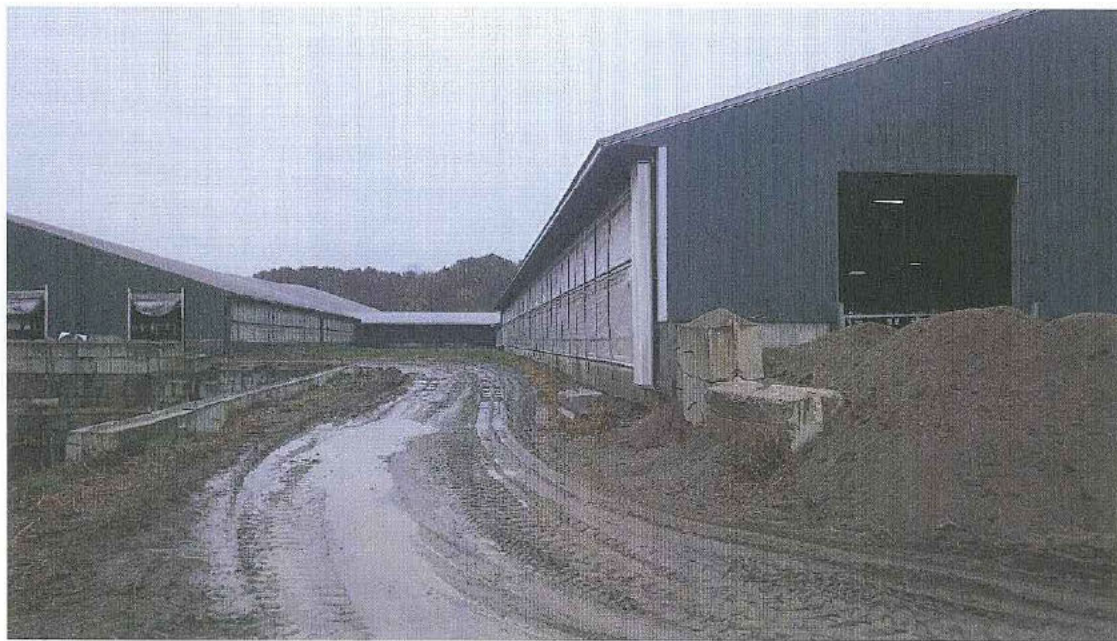
6: RIMG0006

Description: Looking west between North Barn (right) and South Barn (left).

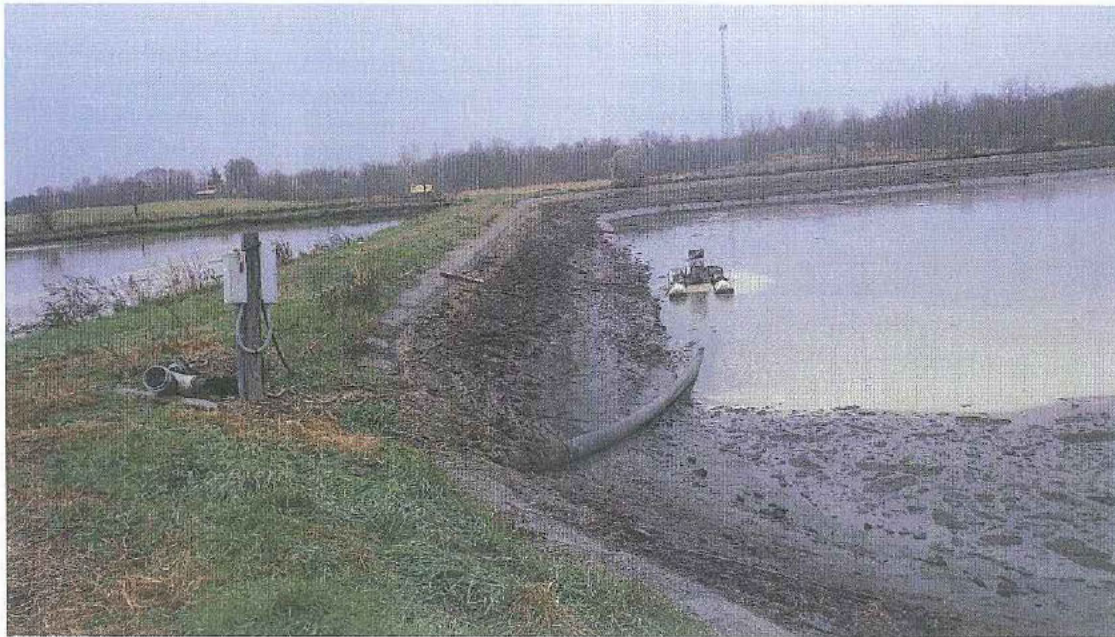
10: RIMG0010

On the south side of the Facility, we observed two wastewater storage structures, Pits 2 and 3. Pits 2 and 3 were both concrete structures with a combined storage capacity of 8.7 million gallons and with Pit 3 being the largest of the two. Pits 2 and 3 were connected via an overflow with Pit 2 draining into Pit 3 via gravity. We observed a freeboard of approximately 1 foot in Pit 1 and 4-5 ft in Pit 3. We did not observe any staff gauges in any of the pits. We did not observe any runoff from the south area of the Facility.

Description: Looking south between manure Pit 3 (right) and manure Pit 2 (left).

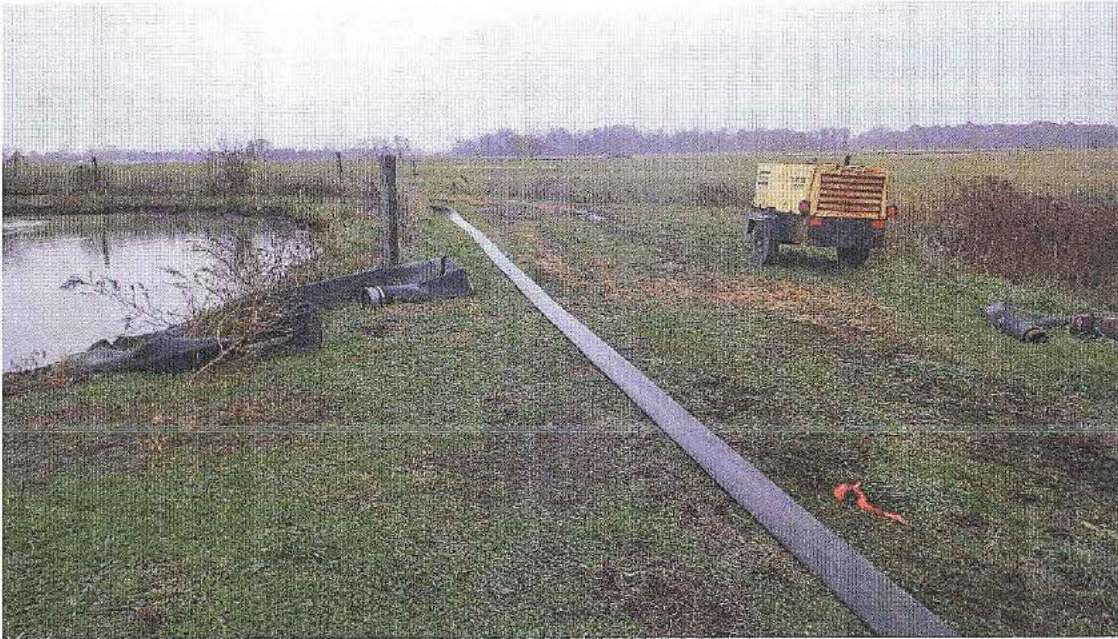
11: RIMG0011

Description: Looking east along south side of manure Pit 2.

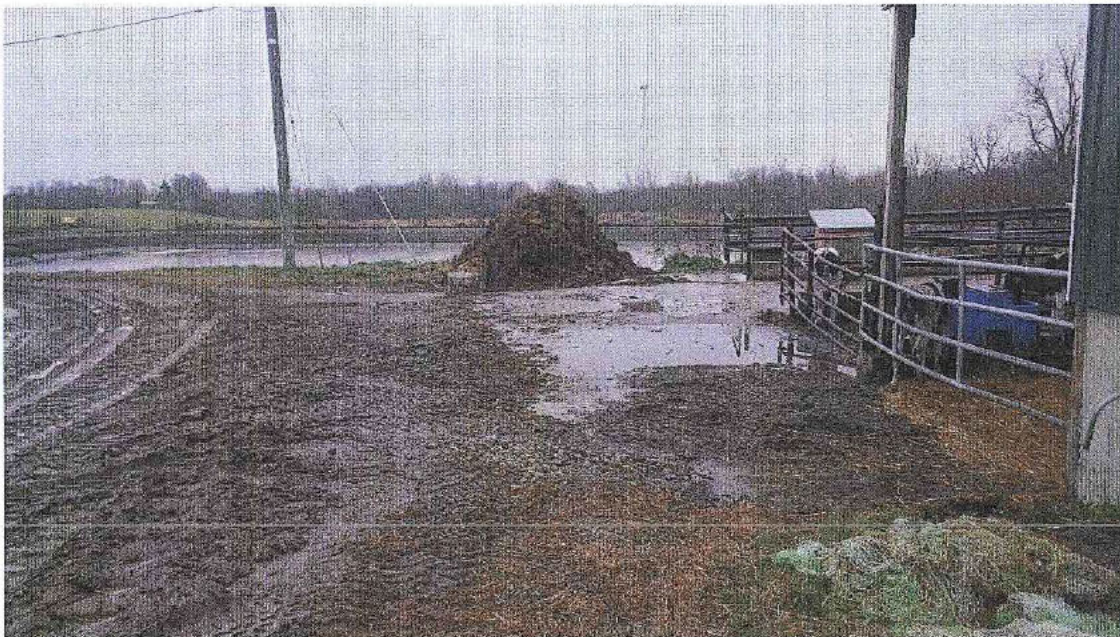
16: RIMG0016

Description: Looking south along east side of the Weaning Pen and associated outdoor lot.

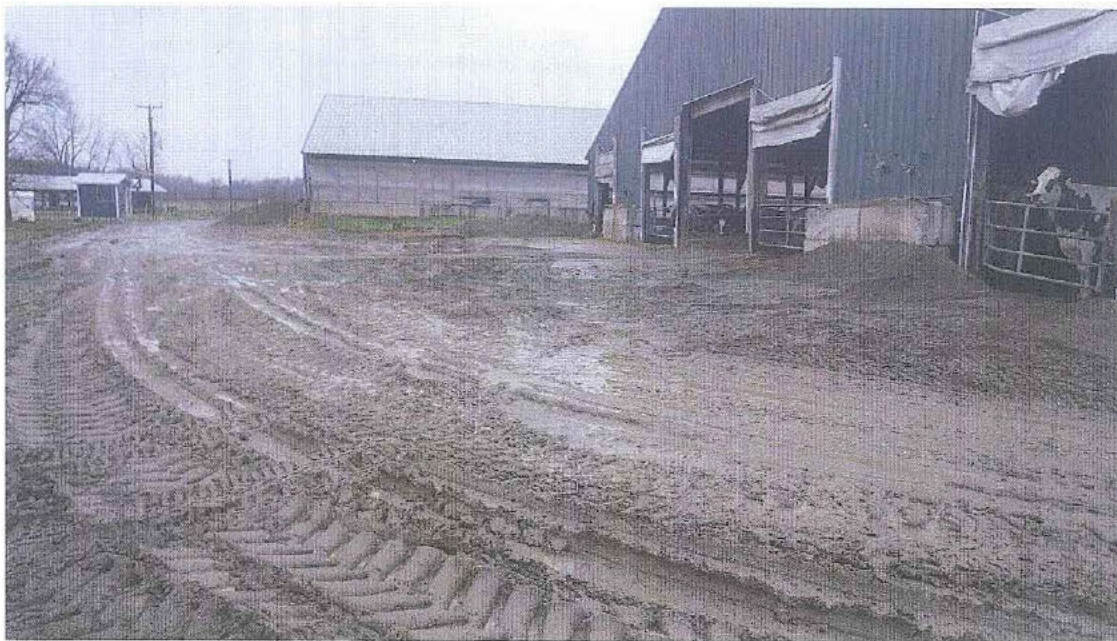
17: RIMG0017

We walked around the west side of the barns and observed some silage and water puddles on the side of the barns, but no runoff leaving the Facility area at the time of the inspection. The ground on the west side of the barns is sloped towards the wetland area.

Description: Looking north along west access road. South Barn in right foreground. North Barn in distance to the right.

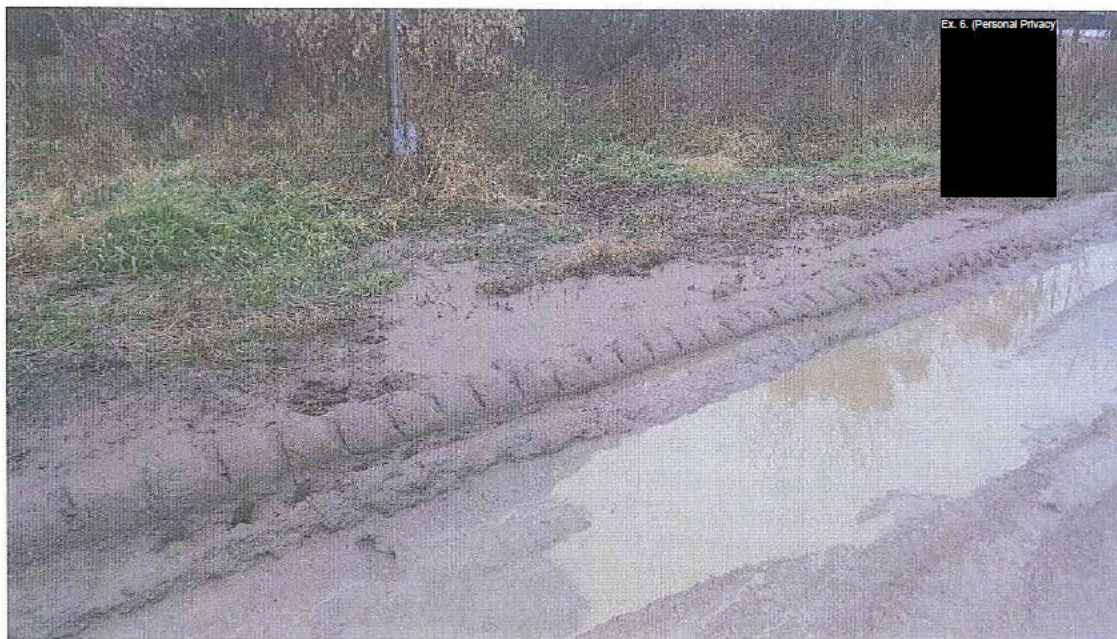
18: RIMG0018

Description: Western edge of west access road west of North Barn.

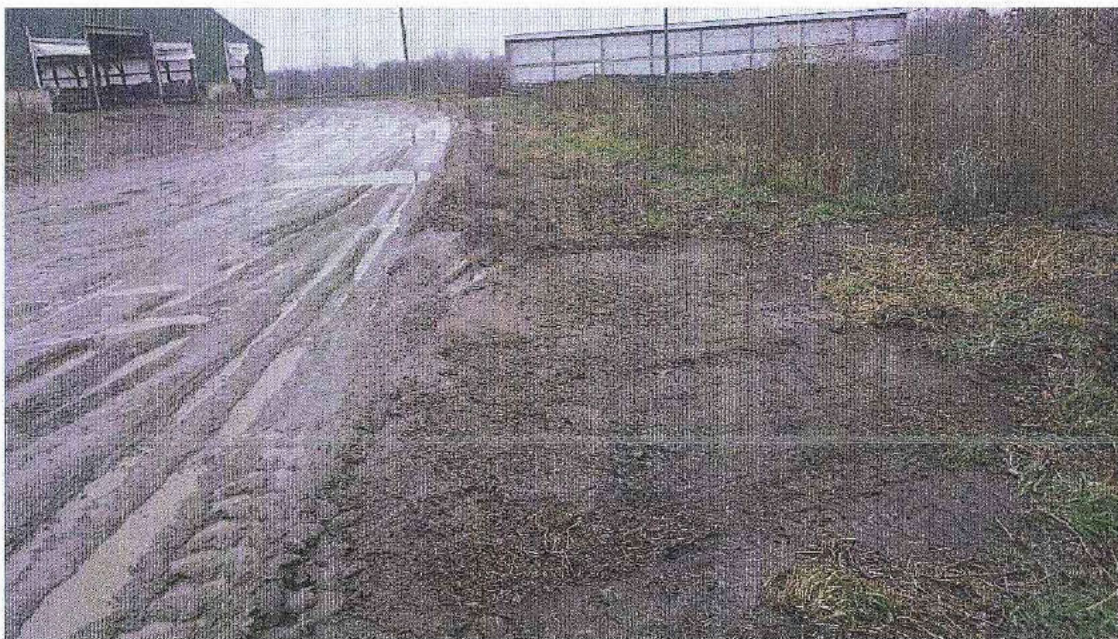
19: RIMG0019

Description: Looking south along western edge of west access road. South Barn in distance left and the Weaning Pen in distance right.

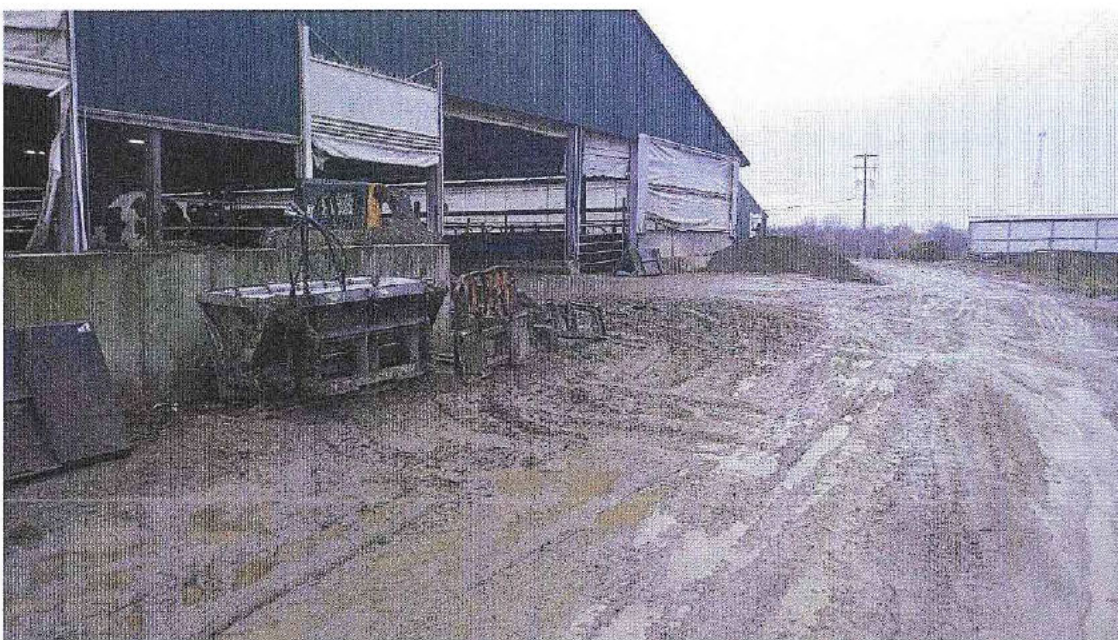
20: RIMG0020

9. EPA observed bedding and feed materials on the west side of the North and South Barns that could result in a runoff towards the wetland area to the west of the Facility. EPA also observed calf hutches with no secondary containment in an area that was sloped towards the inlet of a county stormwater drain.

Description: West end of North Barn.

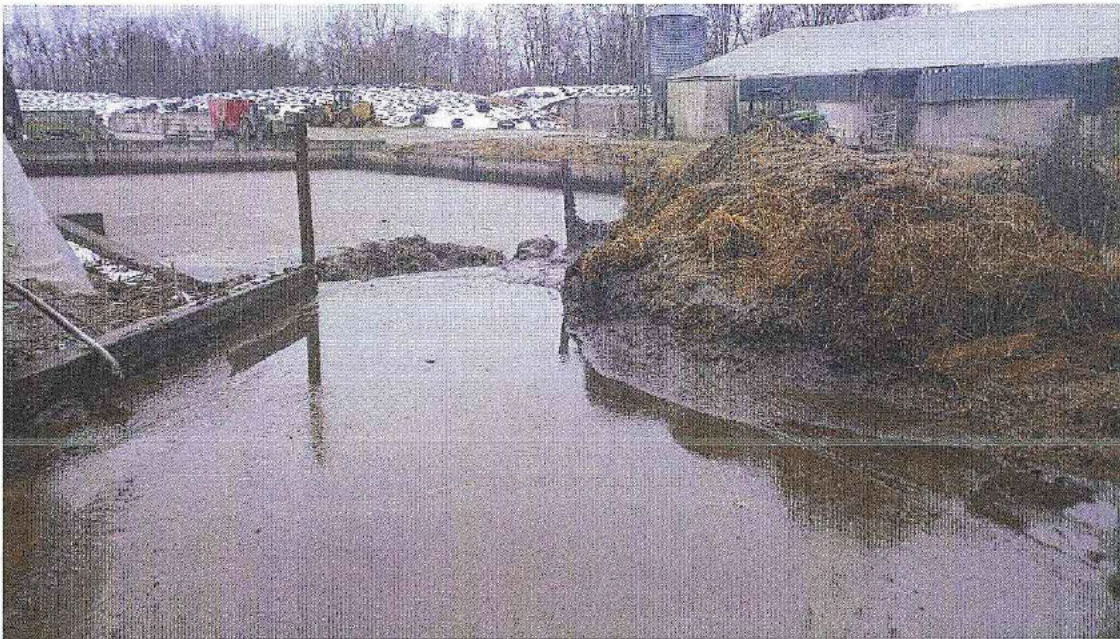
23: RIMG0023

Description: Looking northwest along manure pushout to Leachate Storage.

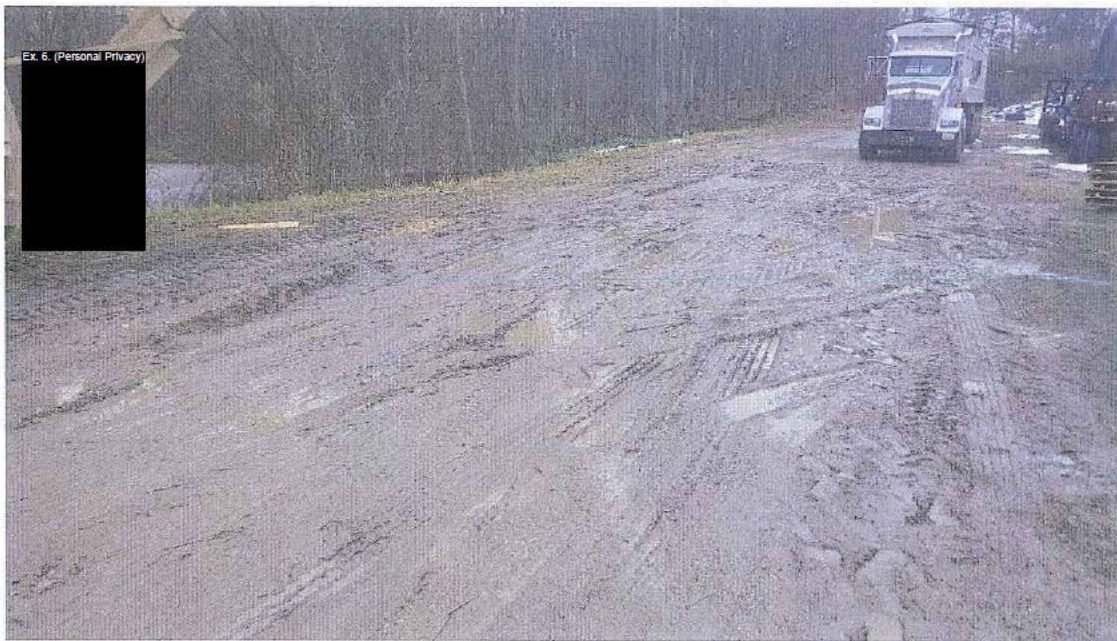
25: RIMG0025

Description: Looking west along access road on northwest portion of facility. Note pond in depressional area to the left.

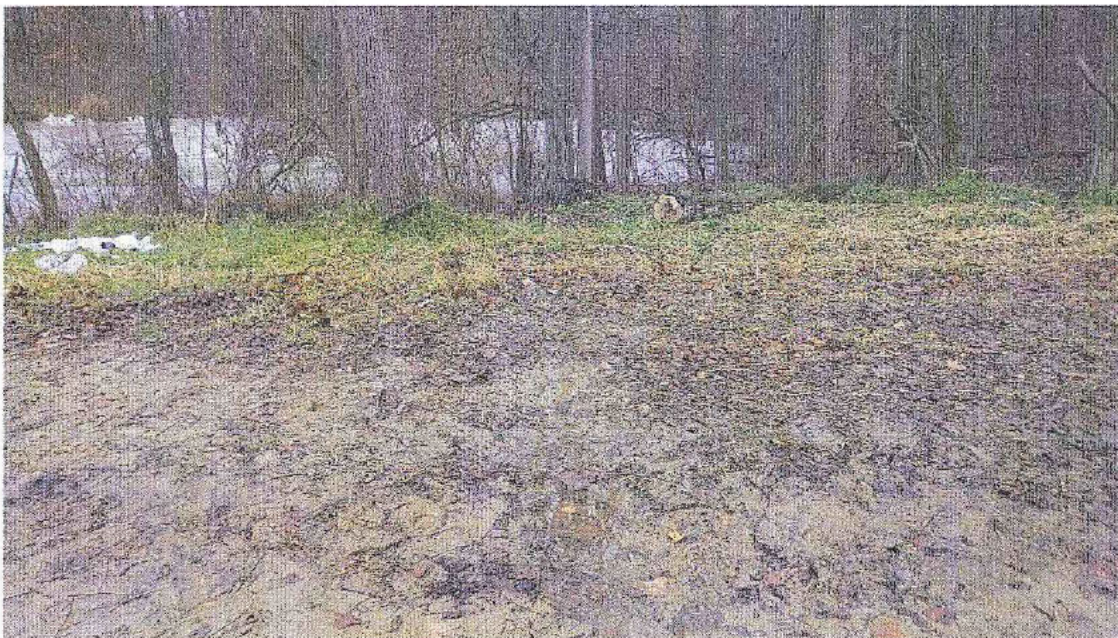
27: RIMG0027

Description: Looking south toward pond in depressional area south of access road.

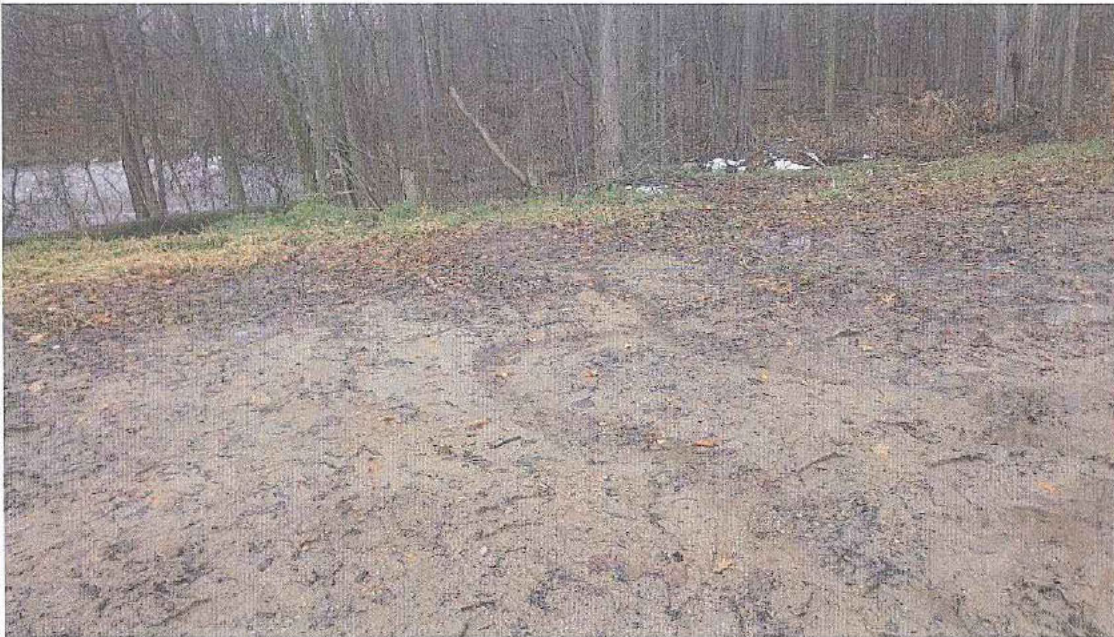
29: RIMG0029

Description: Looking south toward pond in depressional area south of access road.

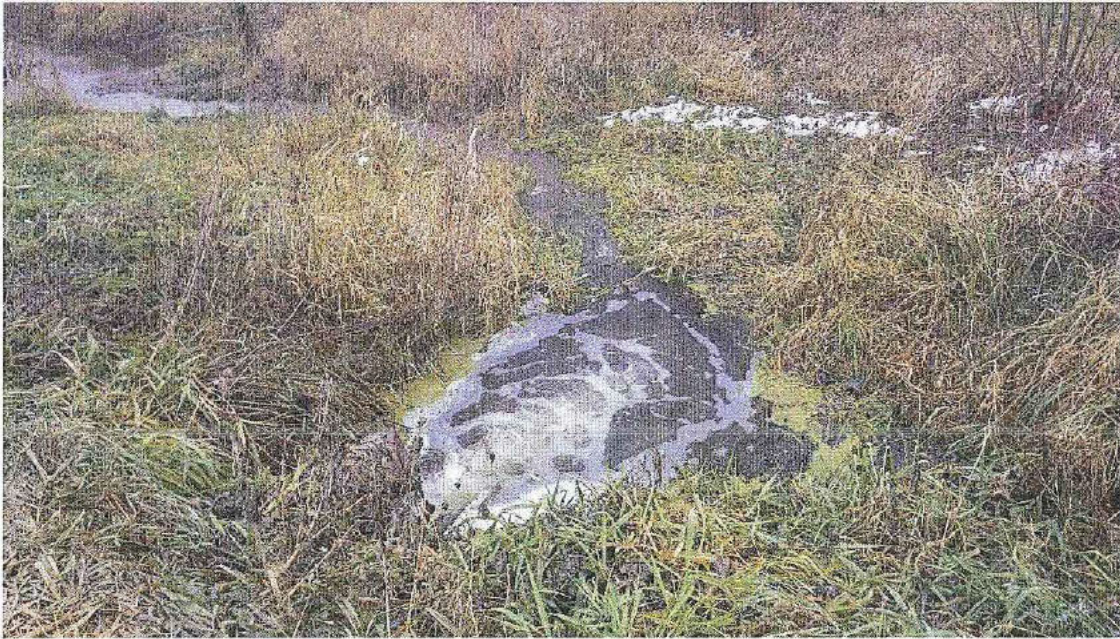
43: RIMG0043

Next, we walked towards the calf hutch area located just north of the office as shown in Figure 2. The calf hutches did not have any secondary containment and they were located on an area that sloped north towards Stewart Road and where the underground County Drain's surface inlet was located (photos 43 - 48). We did not observe any runoff from the calf hatches area towards the County Drain.

Description: Pipe outlet on south side of Stewart Road conveying flow from the pond/wetland area north of Stewart Road.

We held our closing conference around 4:00 pm. We highlighted the good conditions of the manure storage structures at the farm and overall tidiness of the Facility. We also noted to Ex. 6 (Personal Privacy) some of our preliminary observations that included: the need for staff gauges in the manure storage structures, recordkeeping needs to be according to the NPDES permit, better housekeeping around the west end of the North and South Barns that slopes towards the wetland area, and installing containment for the calf hutches to prevent contaminated runoff from reaching the County Drain.

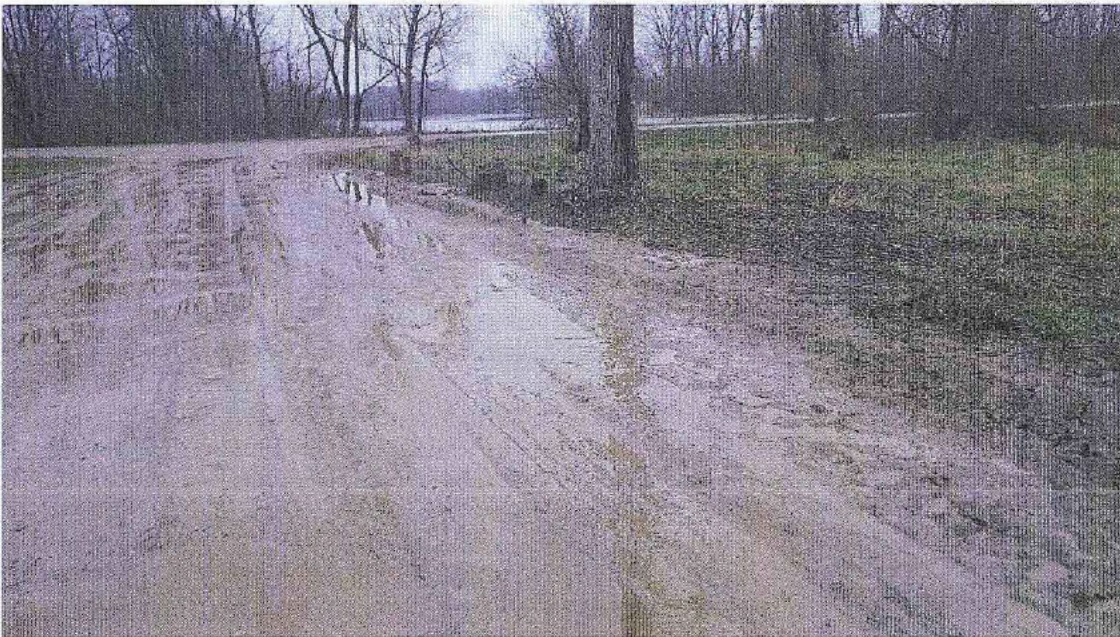
44: RIMG0044

Description: Looking north along east side of main entrance.

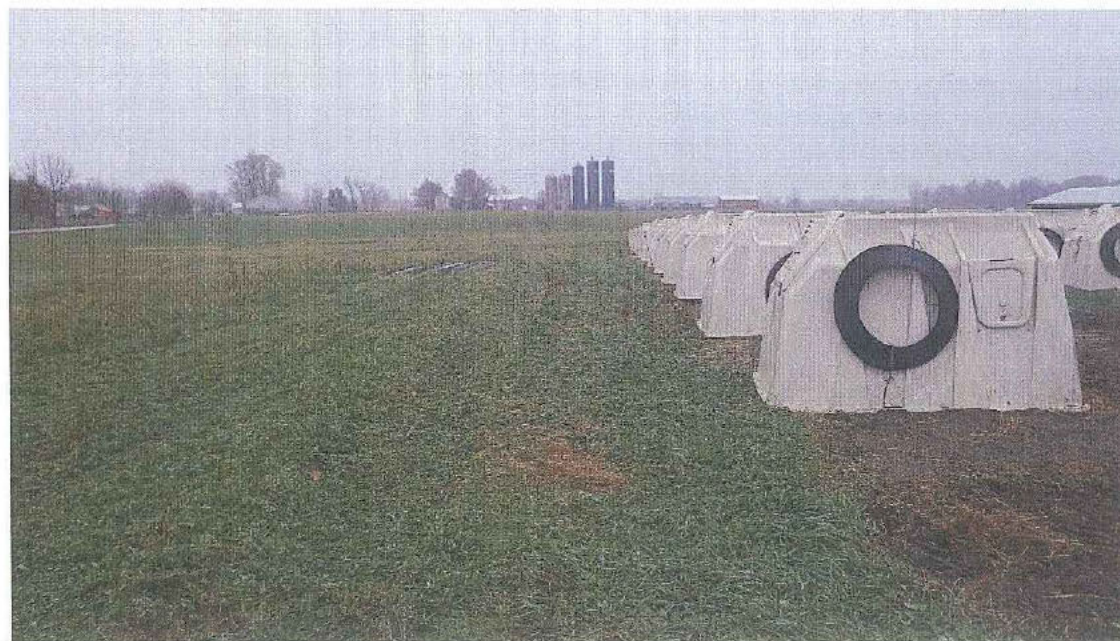
46: RIMG0046

Description: Looking east along northern edge of calf hutch area.

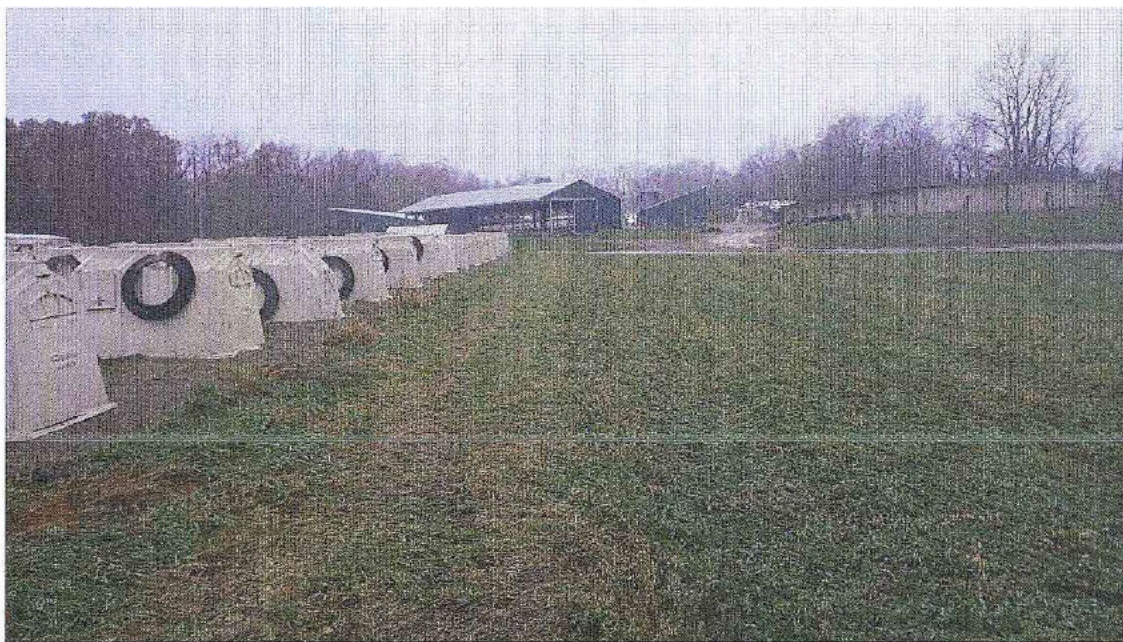
47: RIMG0047

Description: Looking west along northern edge of calf hutch area.

Location: Center of north side of calf hutch area.

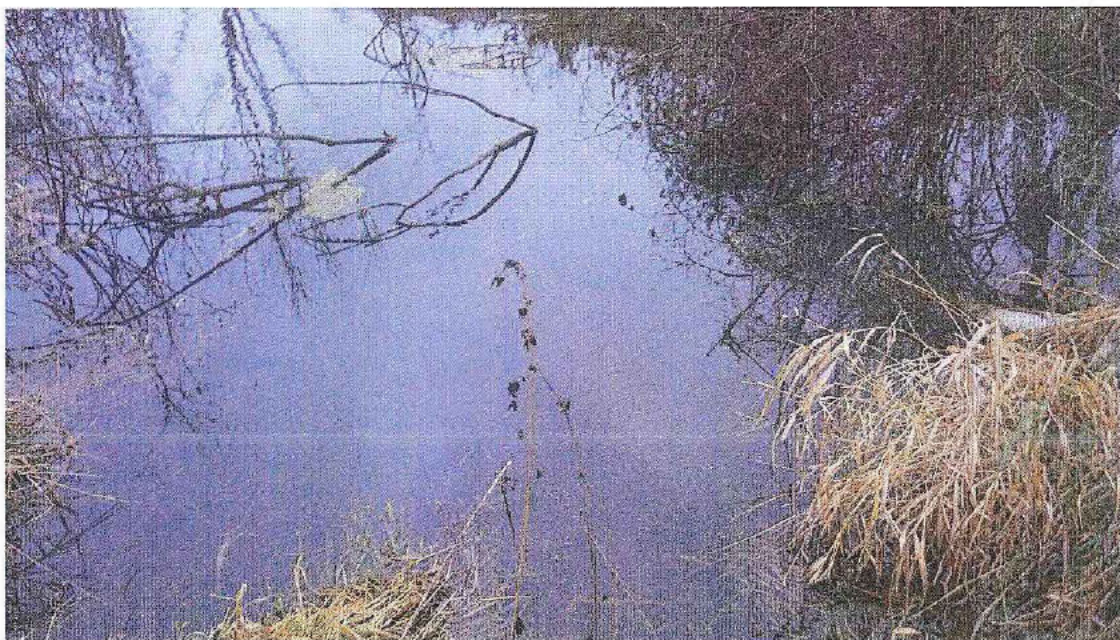
51: RIMG0051

Description: Outlet of pipe (submerged) conveying flow from pipe under Stewart Road.

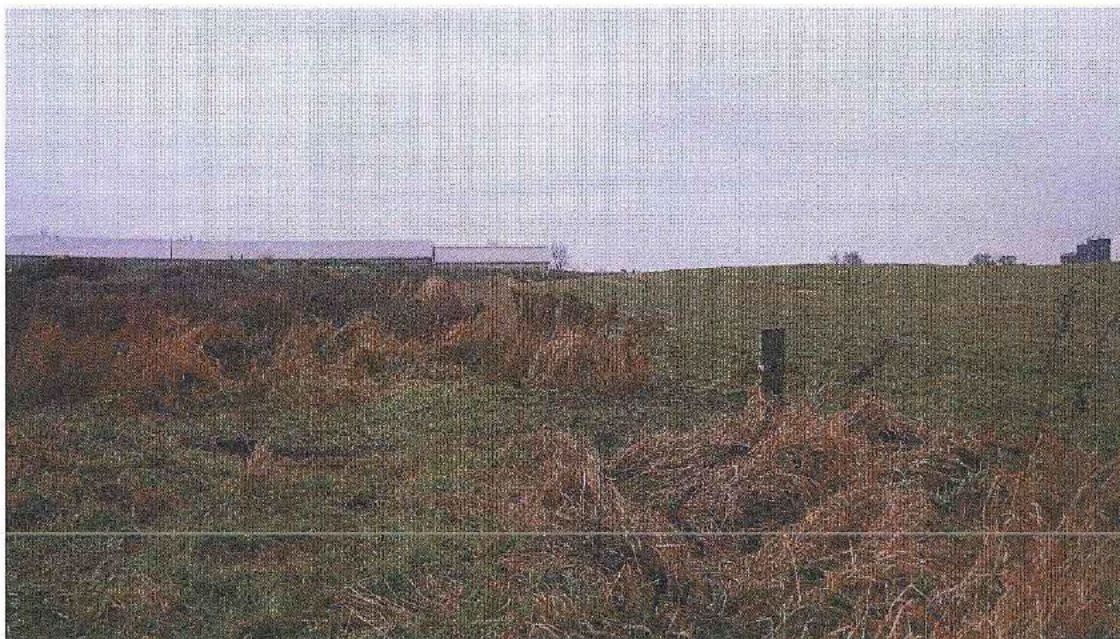
52: RIMG0052

Description: Looking north toward facility at location of outlet pipe conveying flow from pipe under Stewart Road.

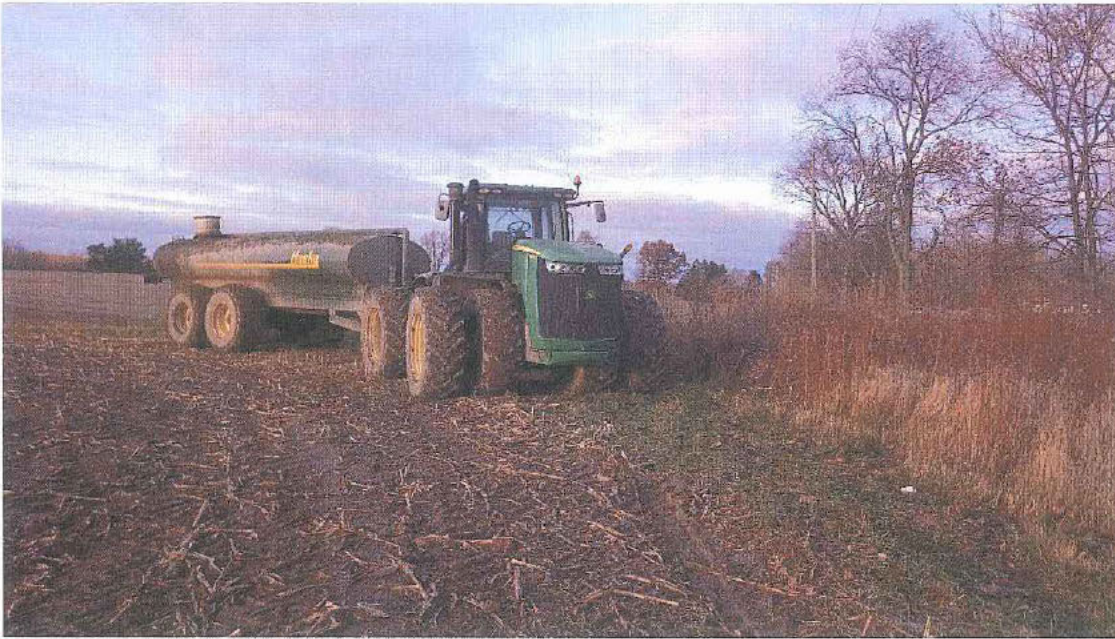
53: RIMG0053

EPA observed a truck hauling manure from the production area's Leachate Storage pond at approximately 10:30 am on November 21, 2019. Ex. 6 (Personal Privacy) (b) (6) stated that manure was being applied to Field Schauer East that morning. On November 22, 2019, at 10:20 am, manure on Field Schauer East was not yet incorporated.

Description: Manure application equipment at location of 11/21/2019 application

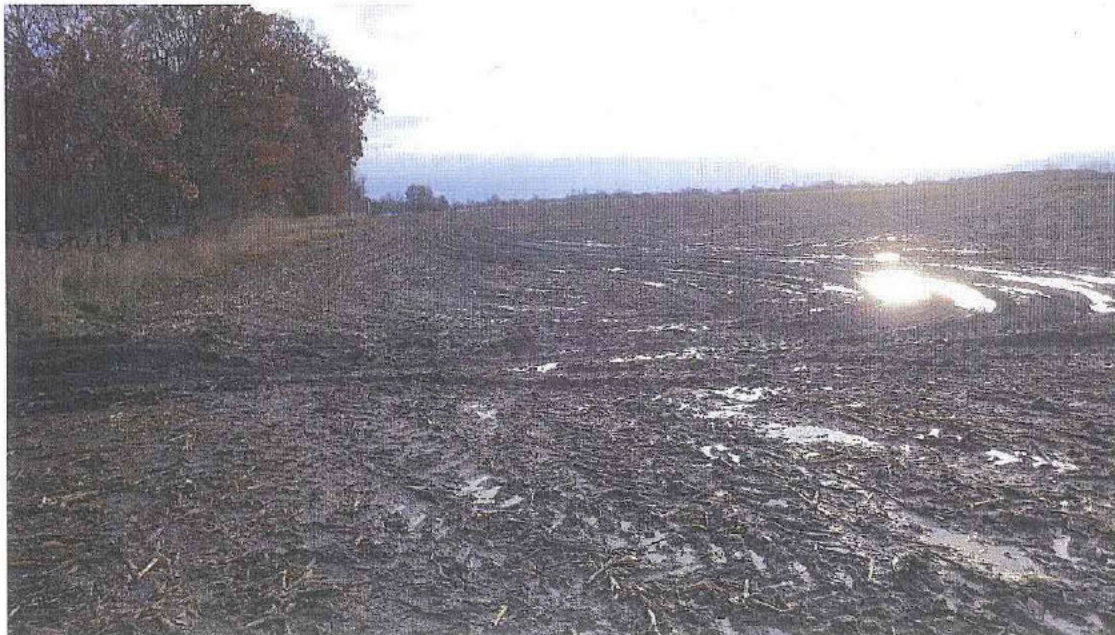
54: RIMG0054

Description: Land Application site approximately 18-24 hours following application.

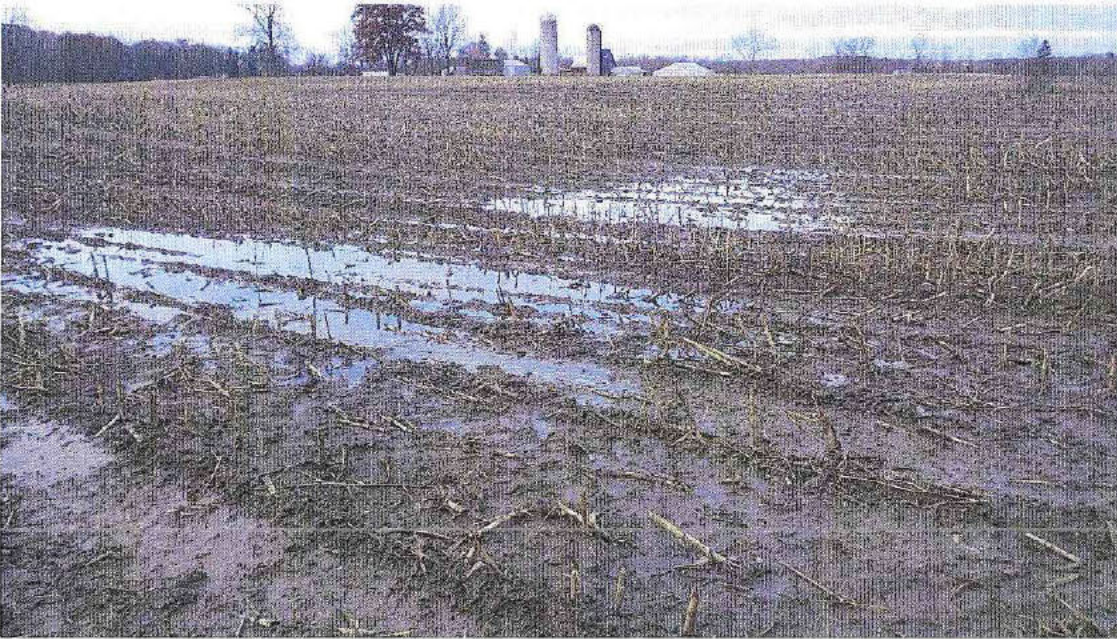
60: RIMG0060

Description: Land application at Field Ex. 6 (Personal Privacy) East approximately 18-24 hours after application.
